**DEPARTMENT OF TRANSPORTATION**

Contract #: 04-0120F4Cty: SF/ALA Rte: 80 PM: 13.2/13.9File #: 99.28**WELDING INSPECTION REPORT****Resident Engineer:**Pursell, Gary**Address:** 333 Burma Road**City:** Oakland, CA 94607**Report No:** WIR-016488**Date Inspected:** 29-Aug-2010**Project Name:** SAS Superstructure**OSM Arrival Time:** 700**Prime Contractor:** American Bridge/Fluor Enterprises, a JV**OSM Departure Time:** 1900**Contractor:** Zhenhua Port Machinery Company, Ltd (ZPMC)**Location:** Shanghai, China**CWI Name:** Li Yang and Zhu Zhong Hai**CWI Present:** Yes No**Inspected CWI report:** Yes No N/A**Rod Oven in Use:** Yes No N/A**Electrode to specification:** Yes No N/A**Weld Procedures Followed:** Yes No N/A**Qualified Welders:** Yes No N/A**Verified Joint Fit-up:** Yes No N/A**Approved Drawings:** Yes No N/A**Approved WPS:** Yes No N/A**Delayed / Cancelled:** Yes No N/A**Bridge No:** 34-0006**Component:** OBG Trial Assembly**Summary of Items Observed:**

Orthotropic Box Girder (OBG) at Trial Assembly Areas

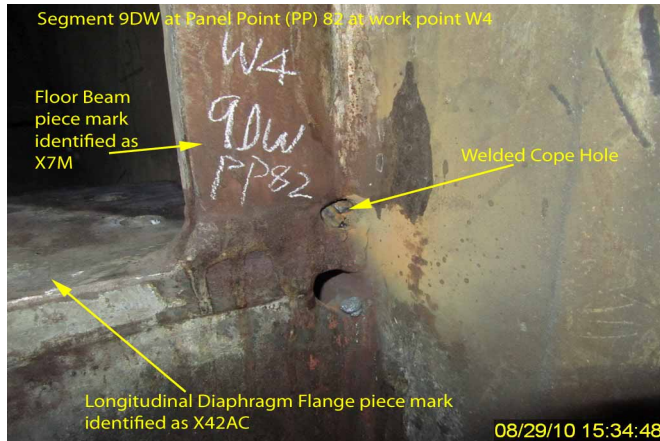
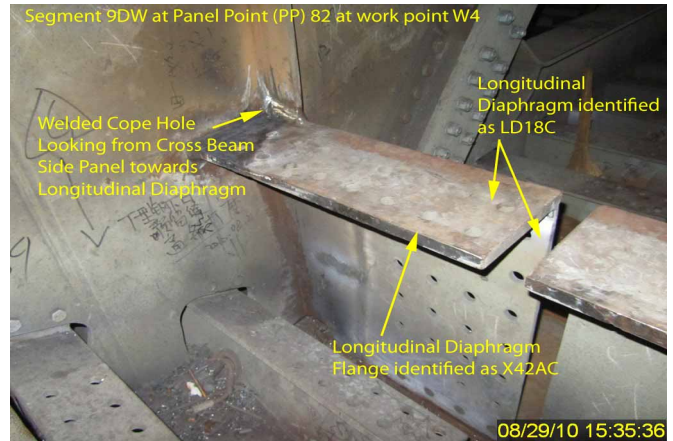
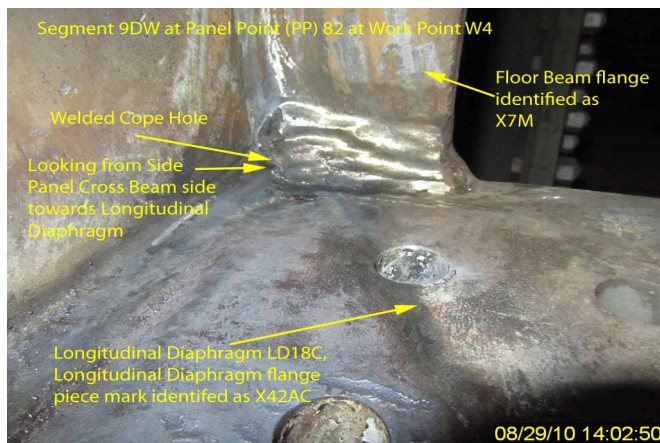
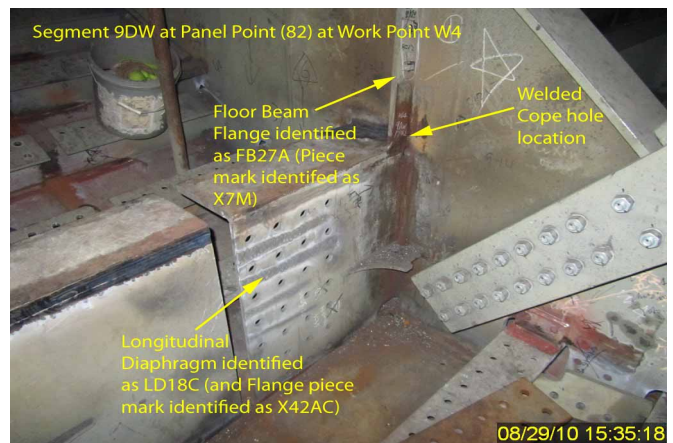
This Quality Assurance (QA) Inspector wrote an Incident Report for welded cope hole at Longitudinal Diaphragm flange to Floor Beam flange termination area as per approved shop drawing FB27A it shall have a radius of R30mm at PP 82 for Segment 9DW at work point W4. Please reference the Incident Report 04-0120F4\_TL-15\_B278\_08-29-2010\_LD\_FB Flange Welded Cope Hole\_9DW at PP 82\_at W4 dated August 29, 2010.

Please reference the pictures attached for more comprehensive details.
